APPENDIX A:
SELECTED AREAS OF STUDY FOR THE SUPPLEMENTAL HSR

BARNSDALL ART PARK - HOLLYHOCK HOUSE

PHASE III

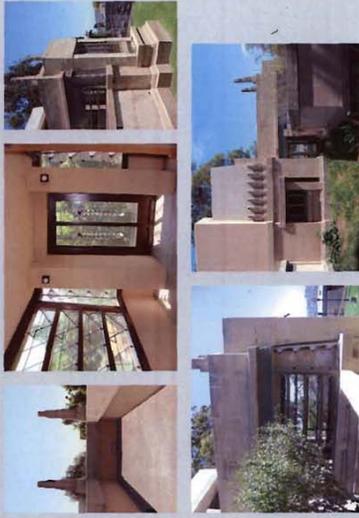
PLAYROOM:

Structure cracks and unsealed roof tile cause water leaks.

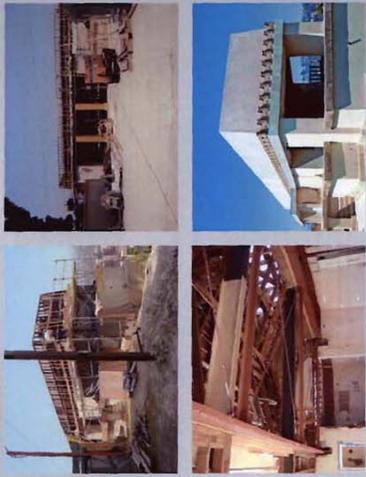
GARAGE:

Phase I construction has strengthened the roof/ parapet only. The garage interior was left functional.

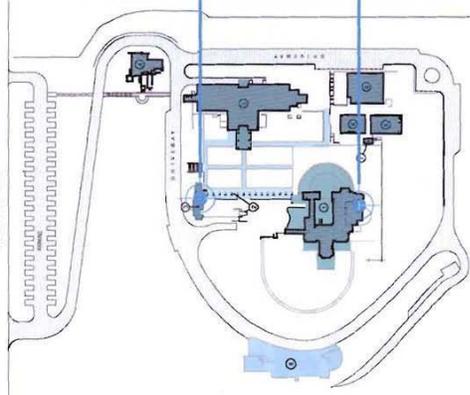
TREE:

Existing tree caused patio structural damage.

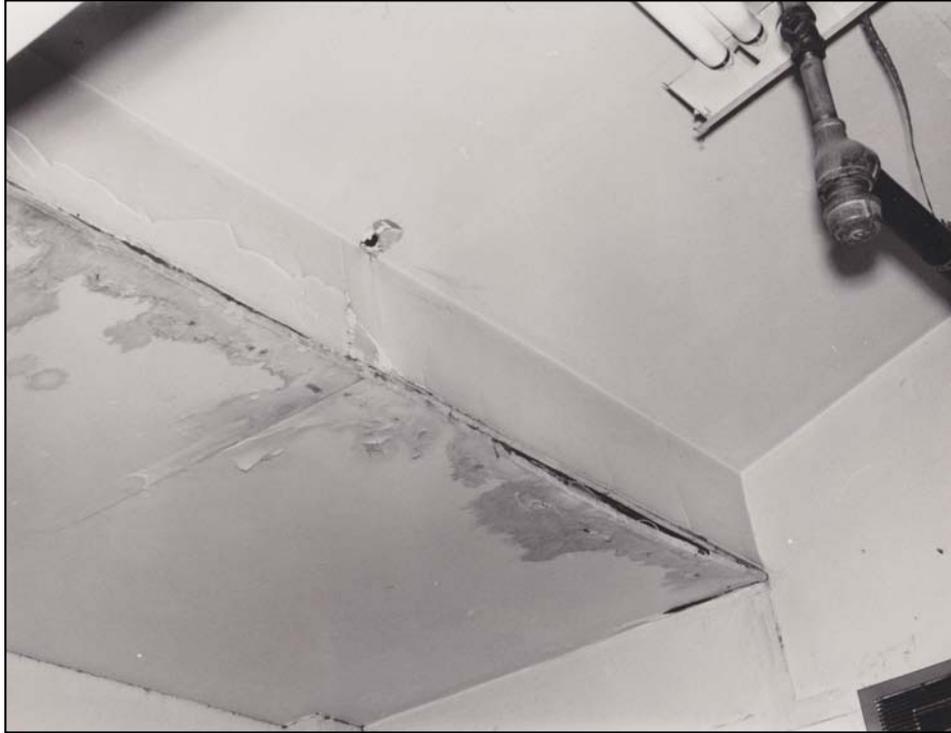
Figure 30: 1979 interior photo of garage building showing water damage.
(Photo credit: Hollyhock House Archives)
