**Residence "A" Barnsdall Park
Los Angeles
Structural Historic Report**

**LSA Associates and Chattel Architecture
Riverside, California**

**Melvyn Green and Associates
Structural Engineers**

STUCCO AND MASONRY - CONDITION REPORT

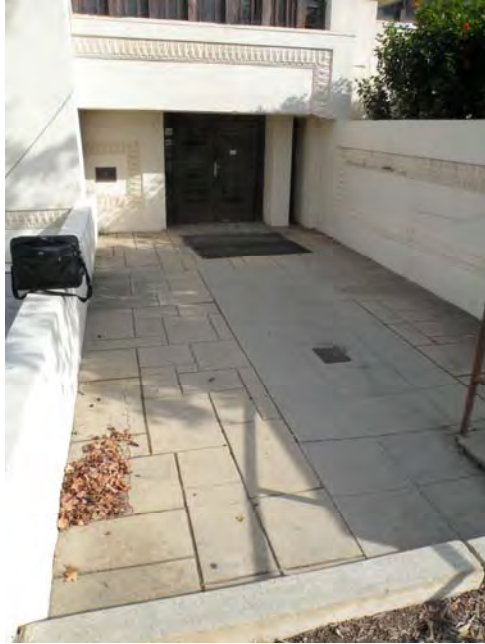
- The existing decorative entry slab is cracked and possibly settling. Inappropriate new concrete has been installed in the center of this entry slab area (*Illustration #2*). Inappropriate concrete access ramp has been added to this area.

#2 – Entry Walkway and Retaining Walls

- Entry: The existing ramp should be removed and the entire entry area reconstructed in a manner more consistent with the original design and construction. Crack repairs of the decorative concrete flooring should be executed after complete cleaning and removal of surface dirt and old coatings.
- Balcony Above Entry: The balcony has likely been subjected to long-term internal moisture penetration, and will require some dis-assembly in order to correct the source of this problem. Once all framing and structural issues are resolved, any previously removed decorative elements can be reinstalled, matching cement stucco applied to the areas of previous removal, and the waterproofing at the deck finished to protect this projecting element.
- North and South Retaining Walls at Entry: Both walls have shifted and may require replacement with newly constructed walls after decorative cast stone

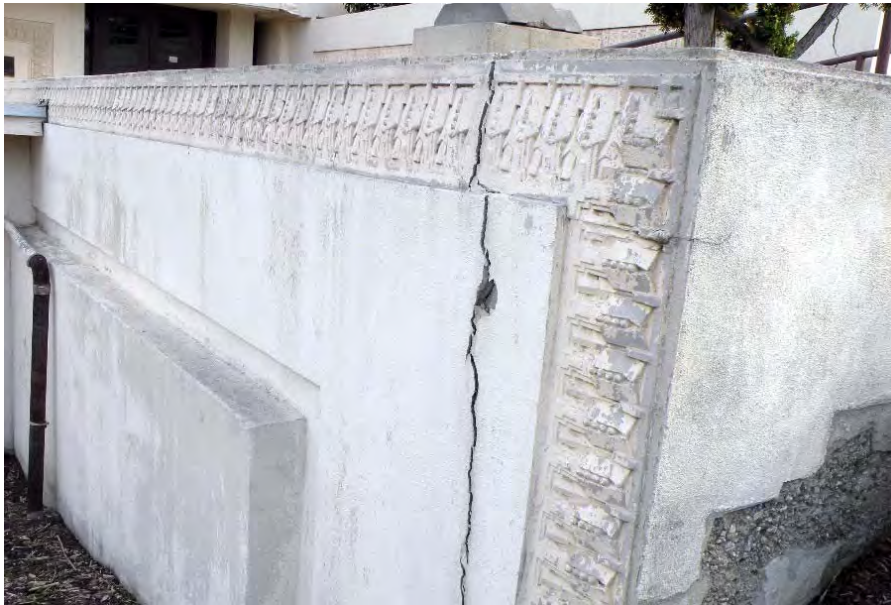
- The north and south retaining walls on either side of the entry walkway have moved over time with noticeable shifting of the foundations. Attached decorative cast stone is cracked and spalled at several locations. (*Illustrations #3+#4*).

#3 – South Retaining Wall at Entry

bands are selectively removed. Once new foundations and walls are completed, salvaged cast stone trim can be reinstalled prior to overall painting.

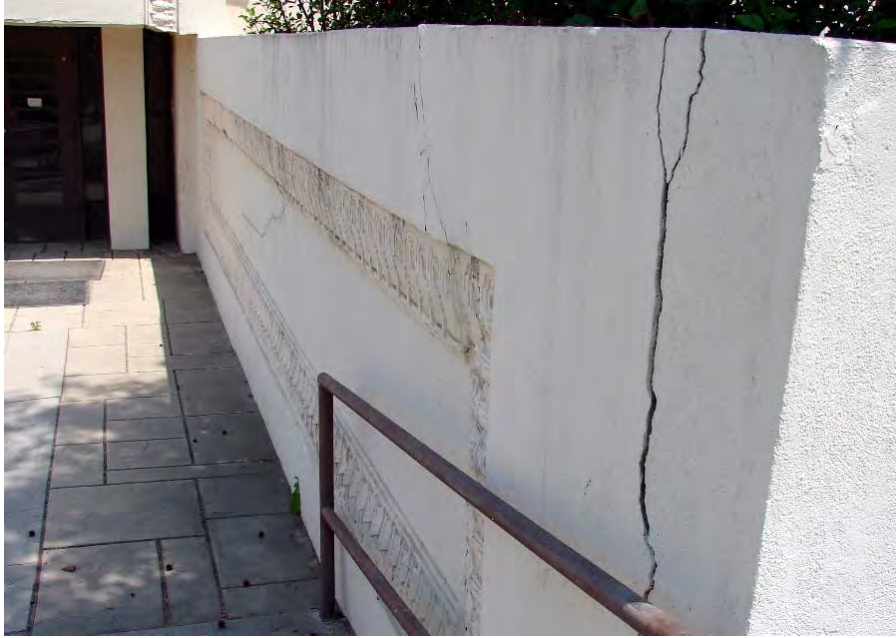
#4 – North Retaining Wall at Entry

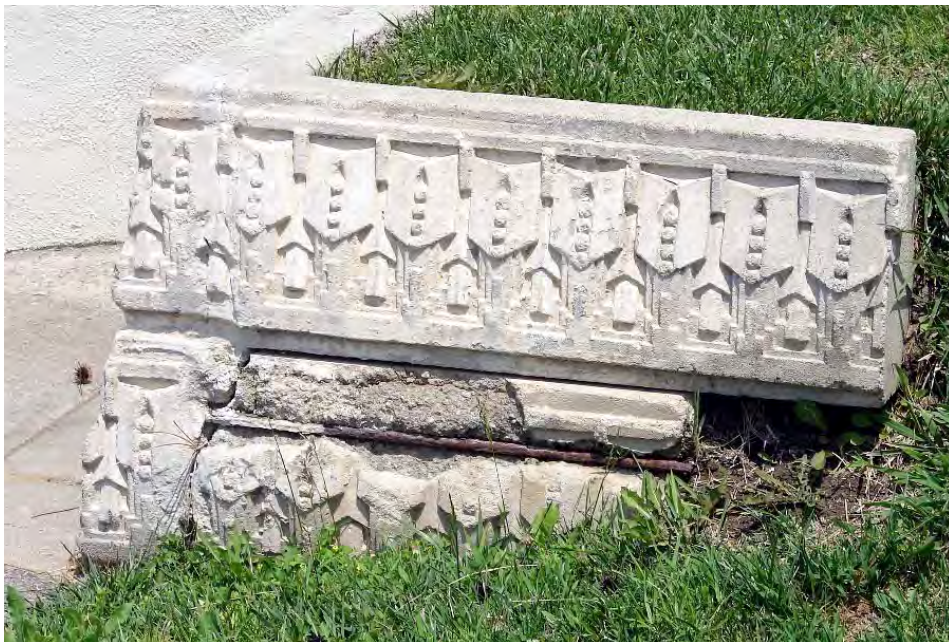
- The planters and smaller retaining walls at the outer entry are also damaged and show signs of shifting foundations and internal metal decay (*Illustration #5*).

#5 – Smaller Retaining Wall at Entry

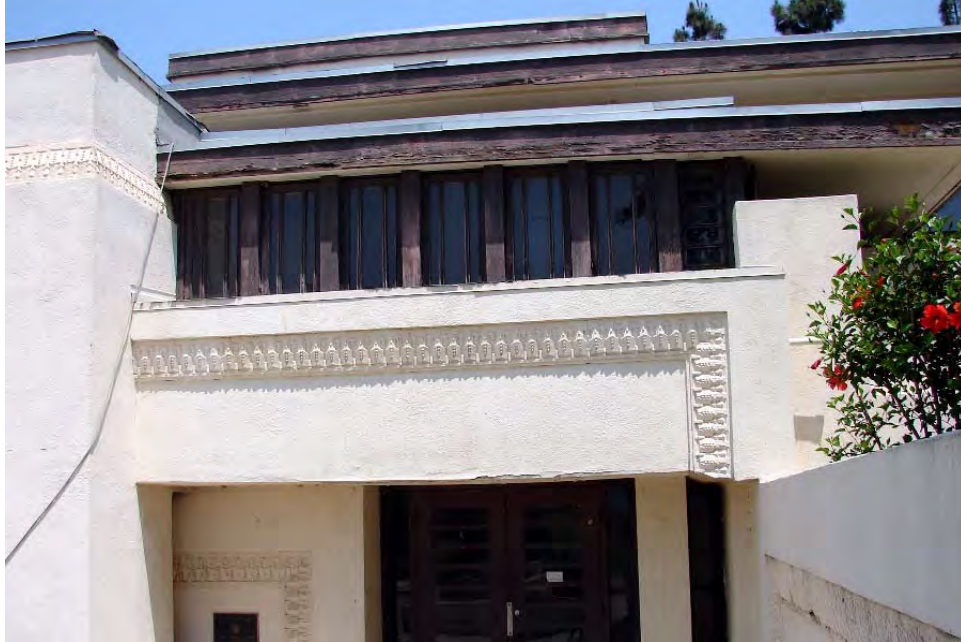
- The balcony above the entry is clearly the victim of water infiltration from likely faulty drains in the deck. This has contributed to the further infiltration of moisture into the structure's internal framing, and caused noticeable movement in the wood, cast stone, and cement stucco (*Illustrations #6 + #7*).

#6 – Balcony Above Entry Door

- North Elevation Balcony: The currently installed balcony is inappropriate and should be removed and replaced with a new balcony matching the original, and constructed of contemporary materials and techniques to yield a more durable projecting element.

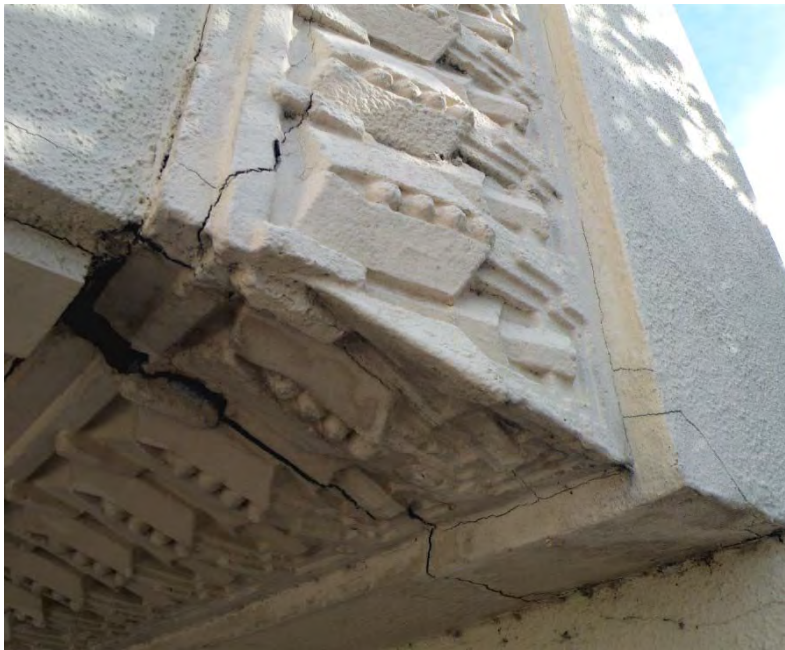
#7 – Damaged Decorative Cast Stone at Balcony

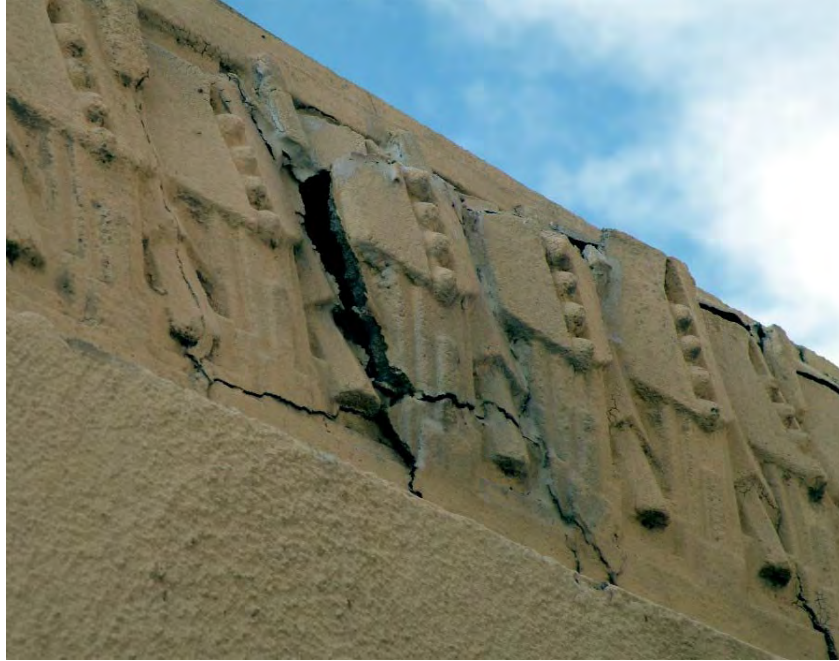
- Maid's room entry has several areas of decorative cast stone trim that are damaged or missing (*Illustration #8*). Possible stucco delamination was also noted.

#8 – Typical Decorative Cast Stone Damage

General comments regarding the exterior masonry components: Decorative Cast Stone: Complete paint removal from decorative cast stone units should be achieved using chemical coatings removers and pressurized rinse water. Grout replacement (repointing) and repair of decorative cast stone should be an important part of repair efforts, since keeping moisture out of the building envelope should be a primary concern. Repointing should consist of removal of the cracked or damaged grout and replacement with new mortar formulated to match the original cleaned mortar in color and texture. Damage and spalling due to ironjacking of interior iron reinforcing components should be repaired after all necessary interior steel repairs are completed. There will also be the required molding and production of approximately 30 lineal feet of new matching decorative cast stone at several locations.

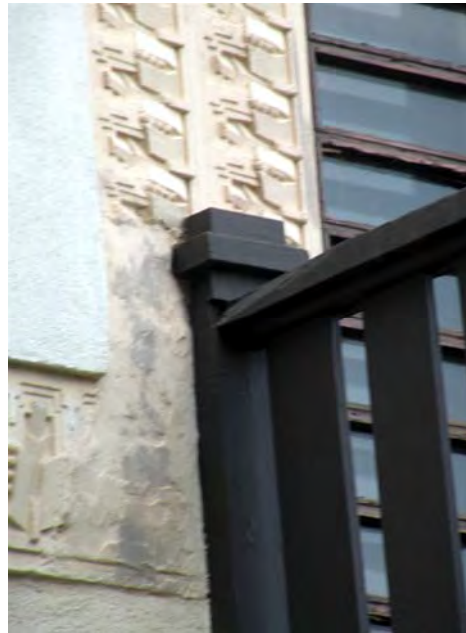
- Wood outbuilding and slab adjacent to the original structure represent an inappropriate addition to the site.
- Evidence of the previously removed balcony attachment indicate the likely location of this missing component (*Illustration #9*).

#9 – Attachment Location of Original Balcony

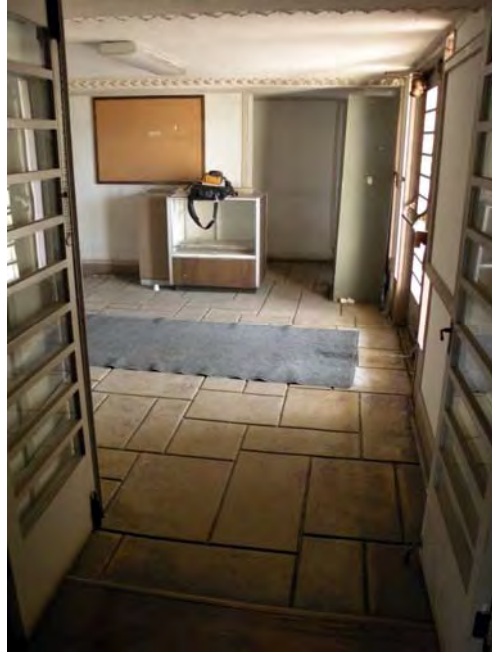
- The entry floor is decorative colored concrete, cast-in-place and scored to represent tile paving. There are numerous cracks throughout this area, and on the similar concrete steps leading to the basement. Old wax coating and soiling have built up on these surfaces over the years (*Illustration #10*).

#10 – Decorative Concrete Floor at Entry Hall

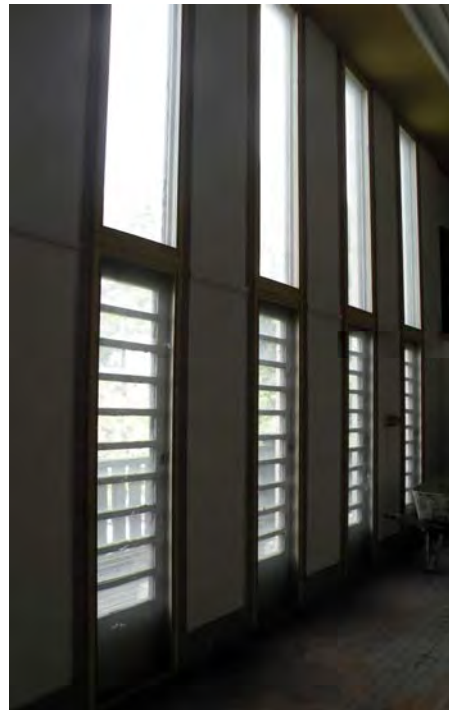
- Though the interior HCT supports are not the focus of this review, it should be noted that an intrusive structural upgrade to these elements between doors would be feasible and welcome, given their current structural enhancement (*Illustration #11*).

#11 – Window Columns at North Elevation

- Living Room Fireplace: In addition to coating removal and general cleaning, this firebox should be exposed and any repair necessary made to restore the original look and appearance.
- North Elevation Balcony Doors and Columns: As mentioned earlier in this report, the hollow clay tile columns between door units can be seismically upgraded *in situ* without complete removal of these components using careful coring and material placement methods.

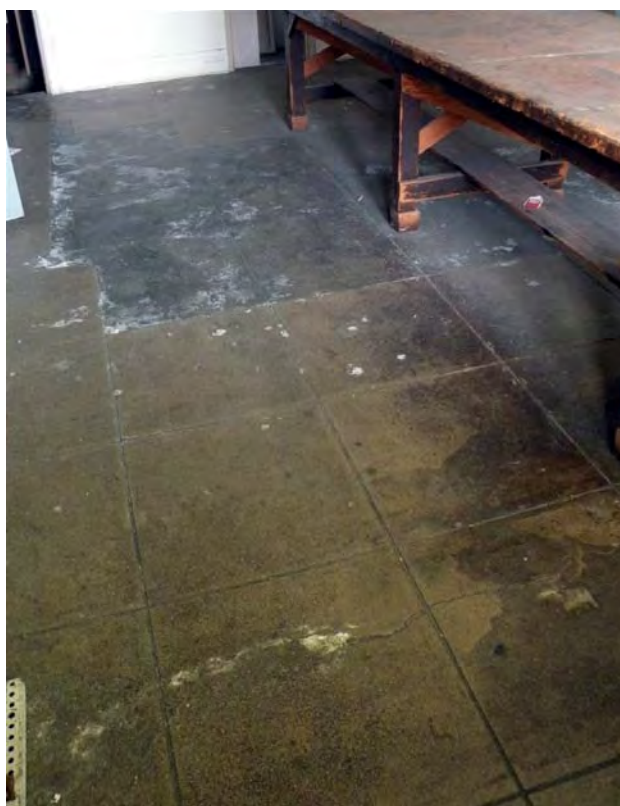
- The original scored concrete floor has been repaired in previous years and has, in addition to normal slab-cracks, an intrusive and inappropriate repair that shows as a non-matching cement patch (*Illustration #13*). Plaster on the lower wall has dissolved and failed at several areas.

#13 – Maid's Room Floor
