APPENDIX C:

PHOTOGRAPHS OF EXISTING CONDITIONS IN SELECTED AREAS OF STUDY

Hollyhock House, Barnsdall Park Los Angeles Supplemental Structural Historic Report

FORENSIC WATER INFILTRATION TESTING REPORT

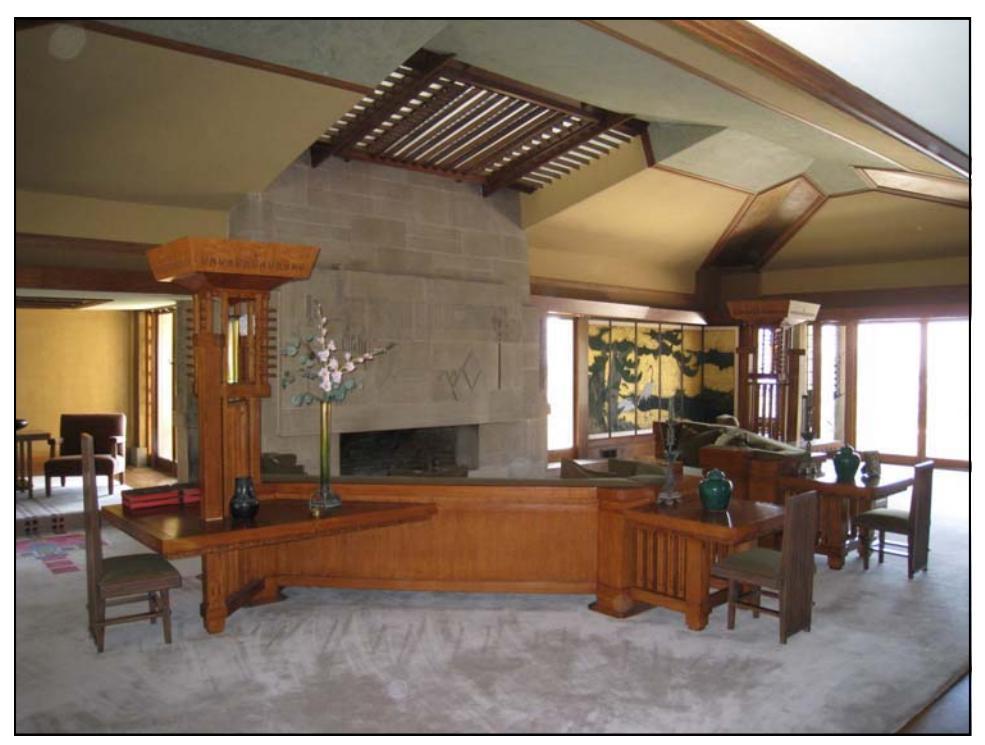
Figure 1: Living room fireplace, view southwest. The three areas of concern regarding the fireplace are the foundation, the chimney and the cast stone mural. (Photo credit: Chattel Architecture, 2009)

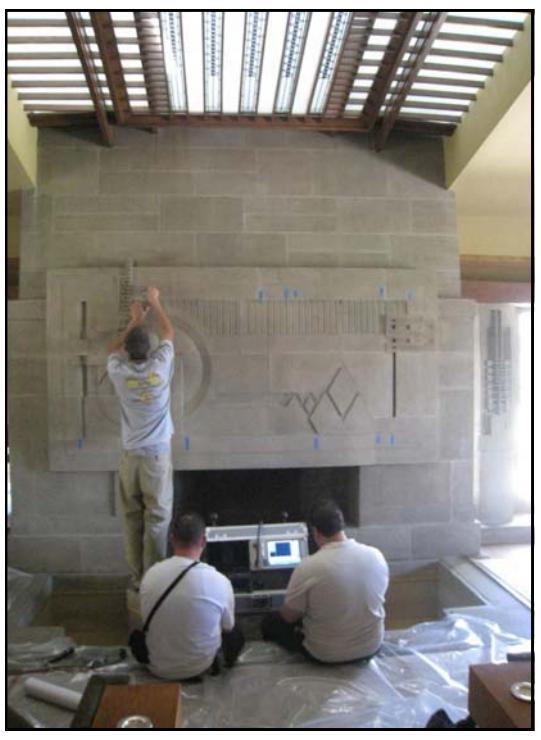
Figure 2: A ground penetrating radar device was used on the surface of the cast stone mural in an effort to determine how it is attached to the chimney, view south. (Photo credit: Chattel Architecture, 2009)

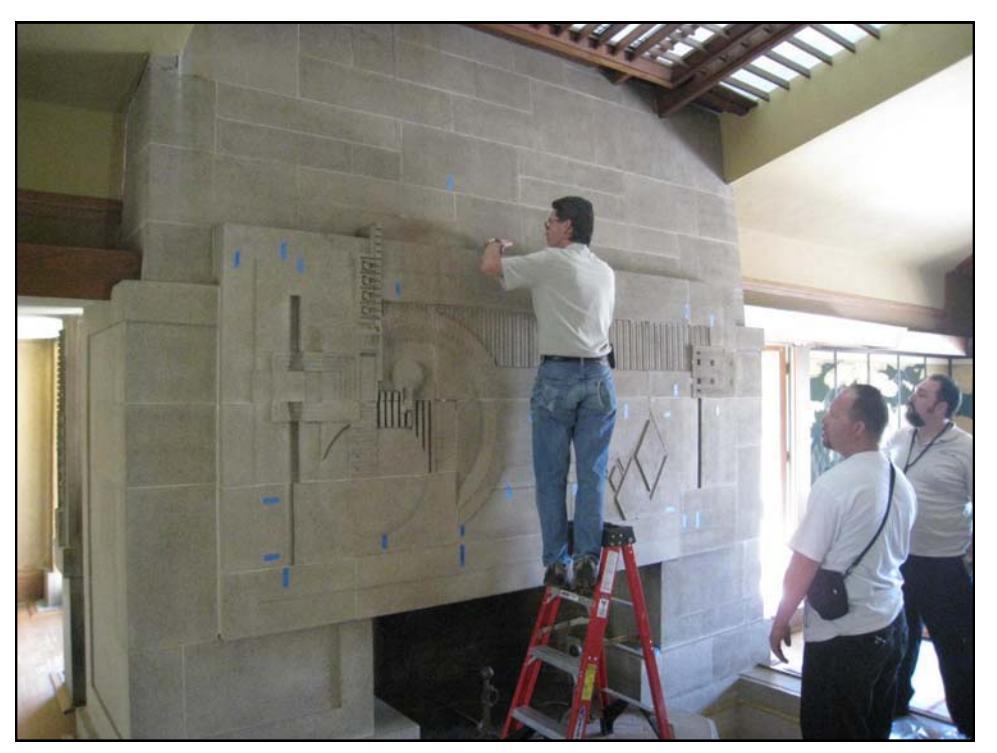
Figure 4: Although some metal ties were identified within the mural, there was not the expected pattern of anchors at each stone corner. However these tests are inconclusive as the ground penetrating radar only detects ferrous metals. (Photo credit: Chattel Architecture 2009)

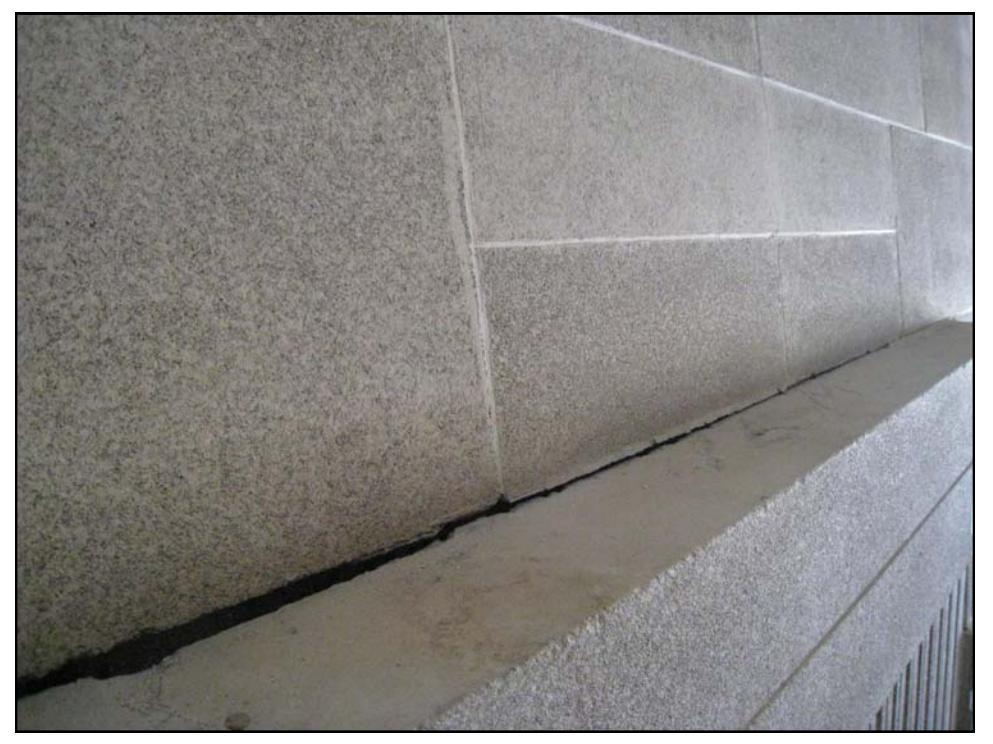
Figure 6: Detail of uppermost portion of the mural where it attaches to the fireplace, view southwest. The Northridge Earthquake caused structural damage to the mural which has shifted up to 1/8 inch. (Photo credit: Chattel Architecture 2009)

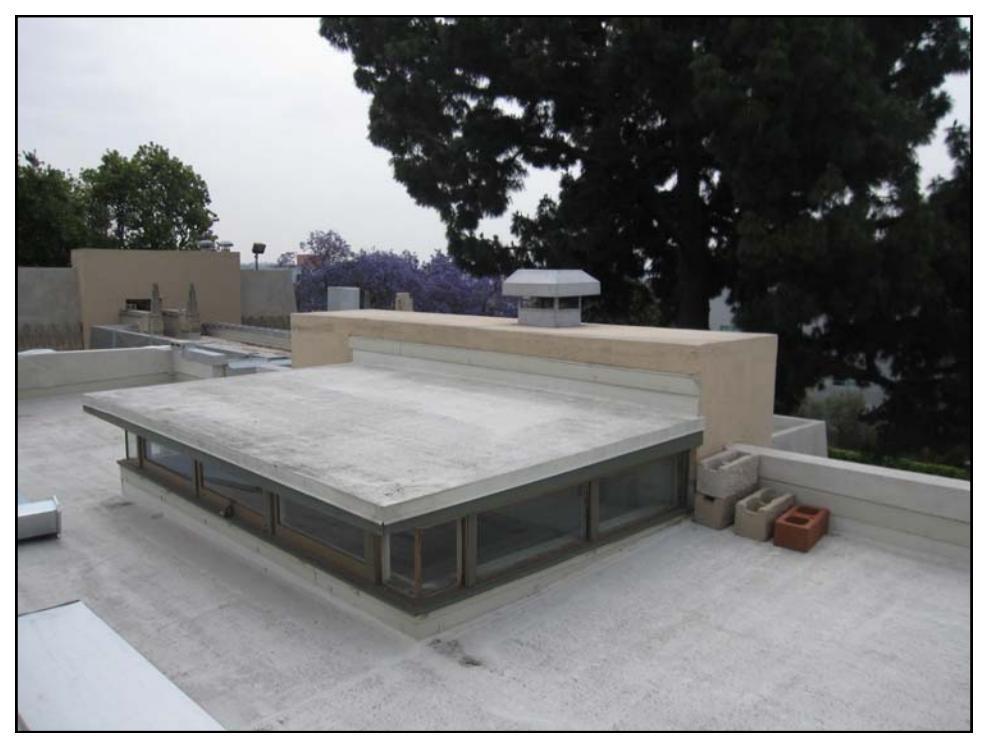
Figure 7: The living room fireplace chimney as it appears from the roof, view southeast. (Photo credit: Chattel Architecture, 2009)

Figure 8: Detail of living room fireplace chimney, view southwest. It is difficult to determine the actual size of the unreinforced masonry chimney as it is enclosed within a wood frame.

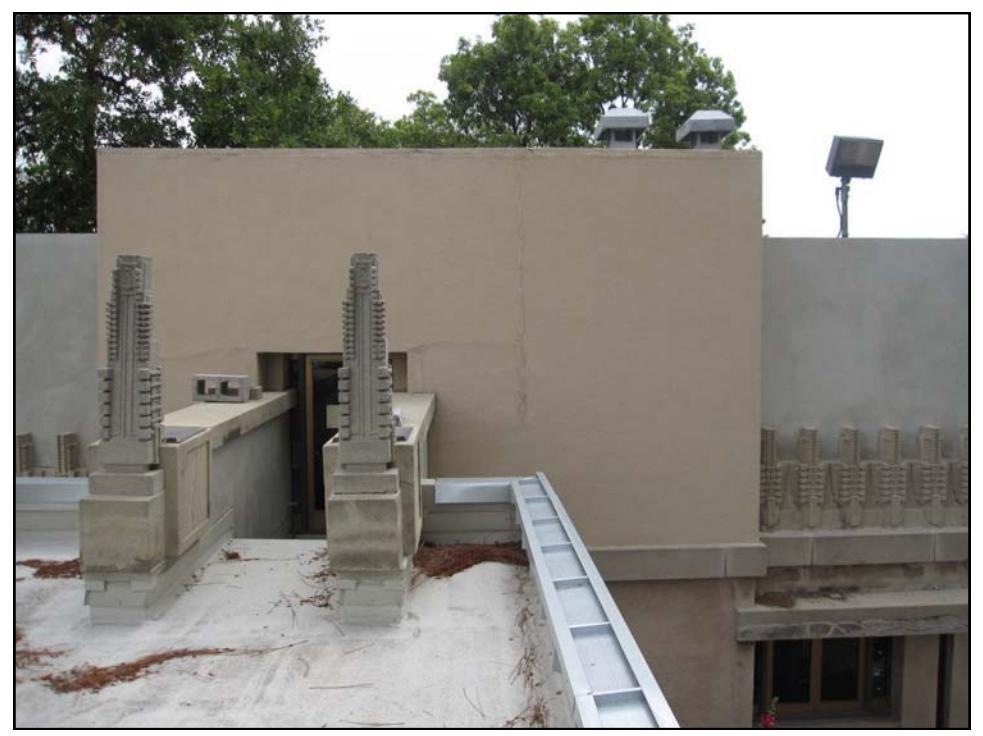
Figure 10: Child's Room and Master bedroom chimney block, view southeast. Cracks occur where the hidden chimney joins the building. (Photo credit: Chattel Architecture, 2009)

The foundation of the Child's Room fireplace chimney should be underpinned in a manner similar to the recommendations for the living room fireplace.

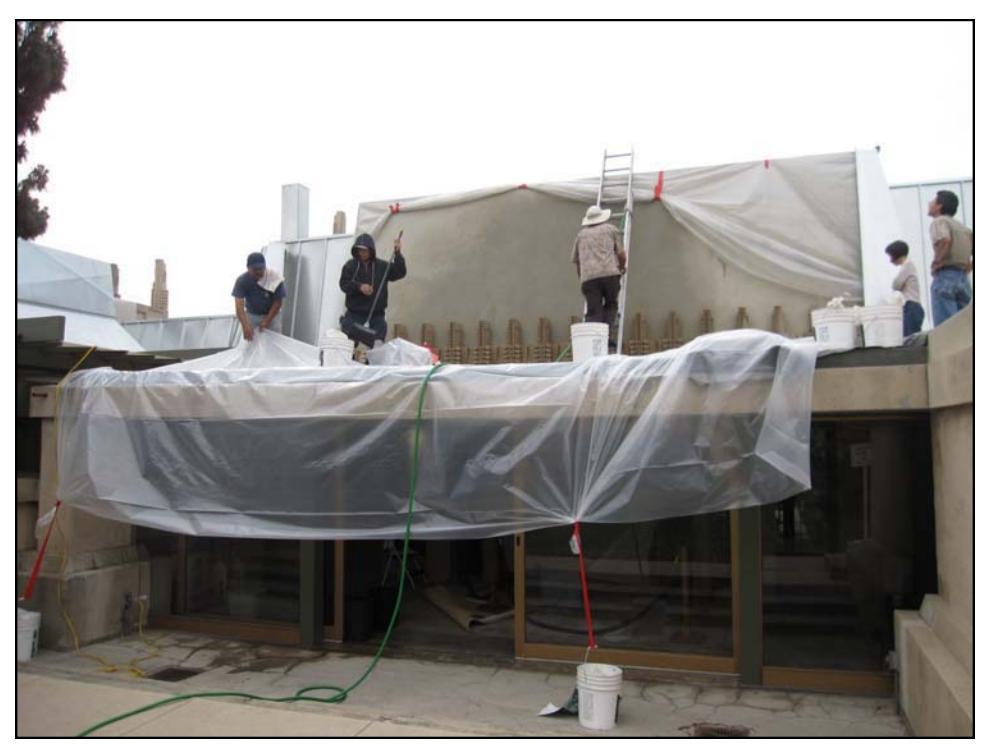
Figure 12: Water testing being conducted on porch roof, view southwest. Note the metal covering was removed from the upper portion of the roof to perform testing. (Photo credit: Chattel Architecture, 2009)

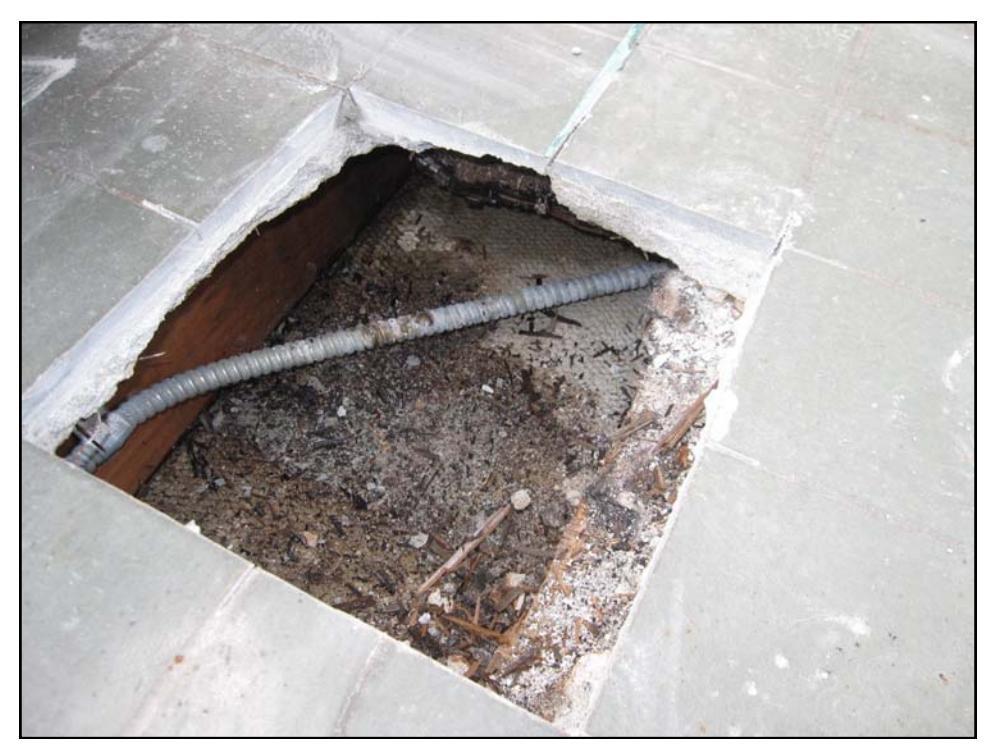
Figure 15: A portion of the patio roof tile was removed to inspect for damage. (Photo credit: Chattel Architecture, 2009)

The sheathing in the area observed was deteriorated and delaminating. The waterproof membrane also appeared to be deteriorated.

If it is decided to retain the deck, it may be possible to add an additional joist between the existing joists. A new layer of plywood should be installed. The concrete substrate for the tile could be sloped to provide positive drainage away from the building into the yard.

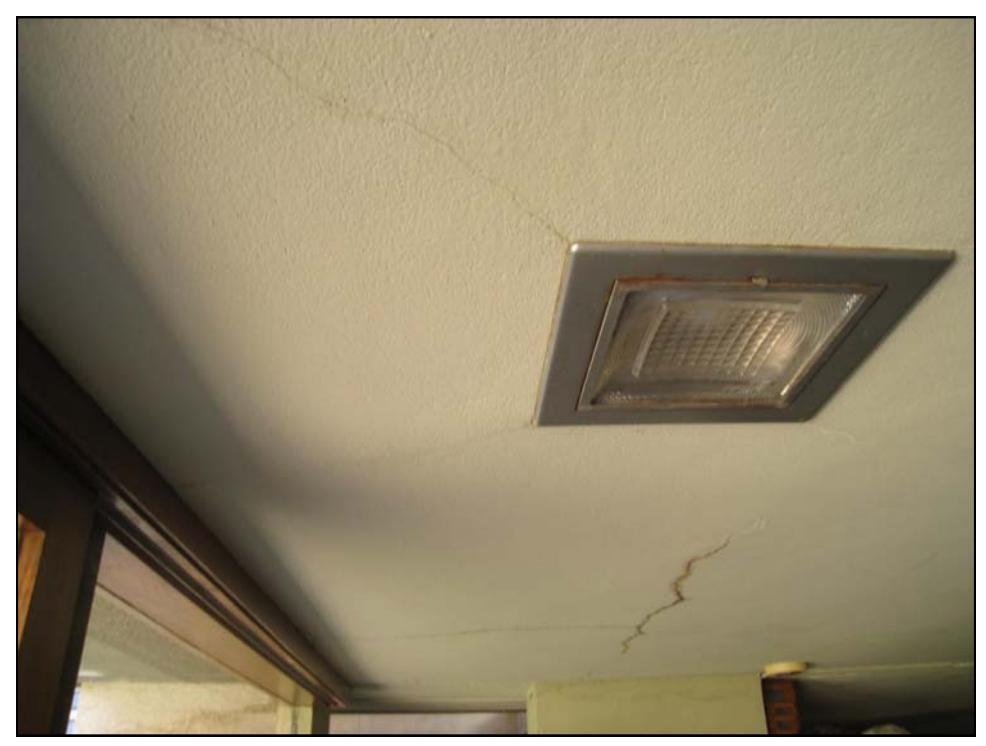
Figure 16: Detail of large cracks on porch ceiling, view south. (Photo credit: Chattel Architecture, 2009)

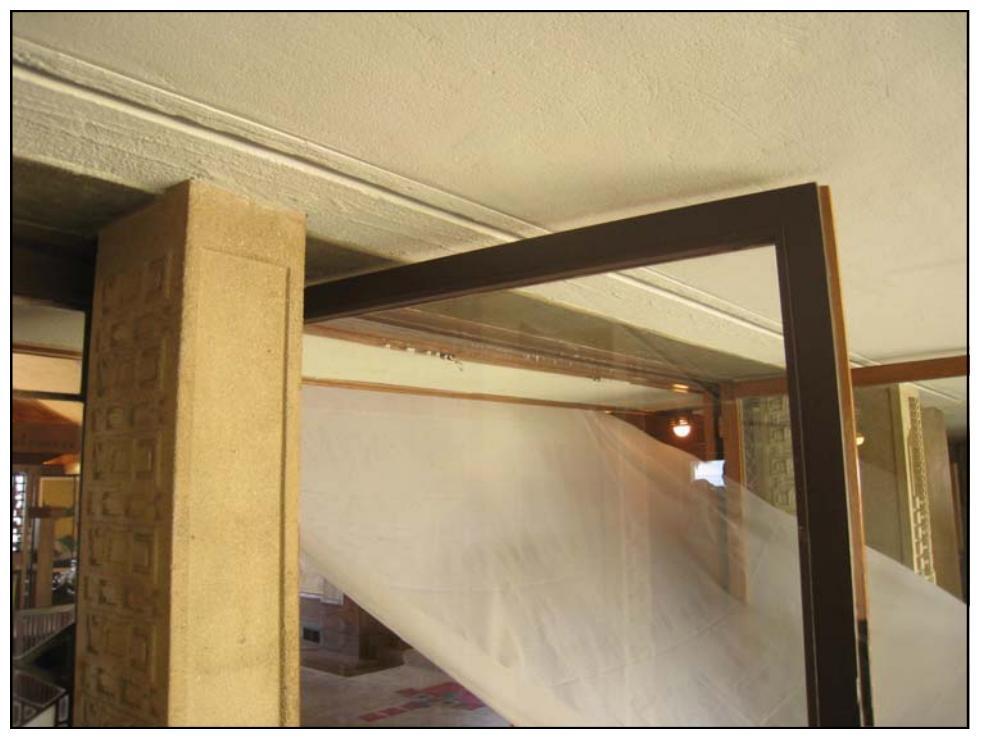
Figure 17: Interior view of porch window openings, view northwest. This particular area within the Gallery has a significant amount of water leakage. (Photo credit: Chattel Architecture, 2009)

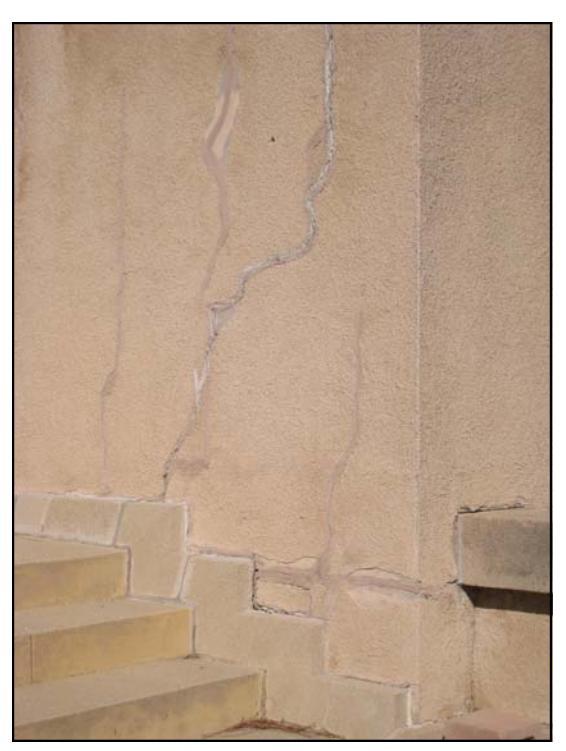
Figure 20: Detail of crack along library exterior wall. (Photo credit: Chattel Architecture, 2009)

At the southwest corner of the library is a vertical crack. This was thought to be a result of the earthquake. However, it appears that there may be settlement at that corner of the library.

In addition, the installation of horizontal stainless rods at the 1/3 points of the walls height should be considered.

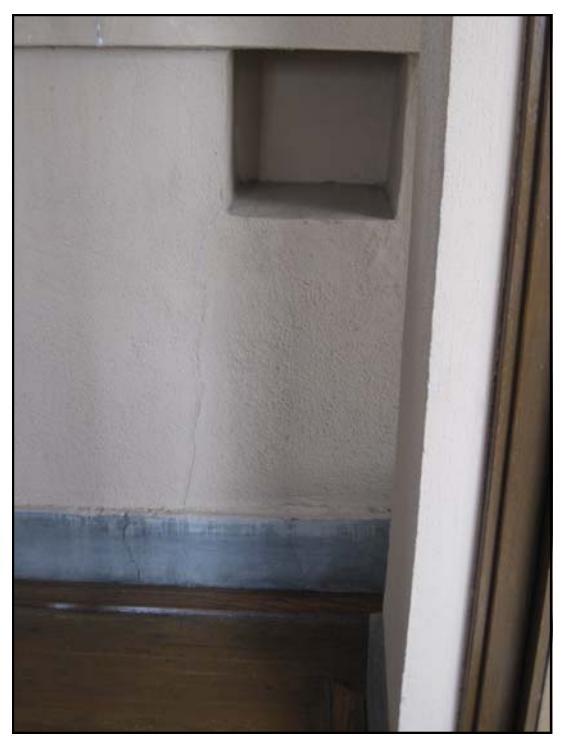
Figure 22: Detail photo of crack along east wall in sunroom. (Photo credit: Chattel Architecture, 2009)

A vertical crack occurs in the east wall of the Conservatory, gridline 6, located about 4 feet to the north of the south wall. The crack extends from the floor/foundation to the underside of the window. The crack has been noted for a number of years and was discussed in the original Historic Structure Report on the Hollyhock House.

Cracks usually occur between different materials. In this case, the main factor is differential settlement between the two sections of foundation. (Why this occurs on the east wall, and not the west, is unknown.) A second factor is that the earthquake likely caused some widening of the crack.

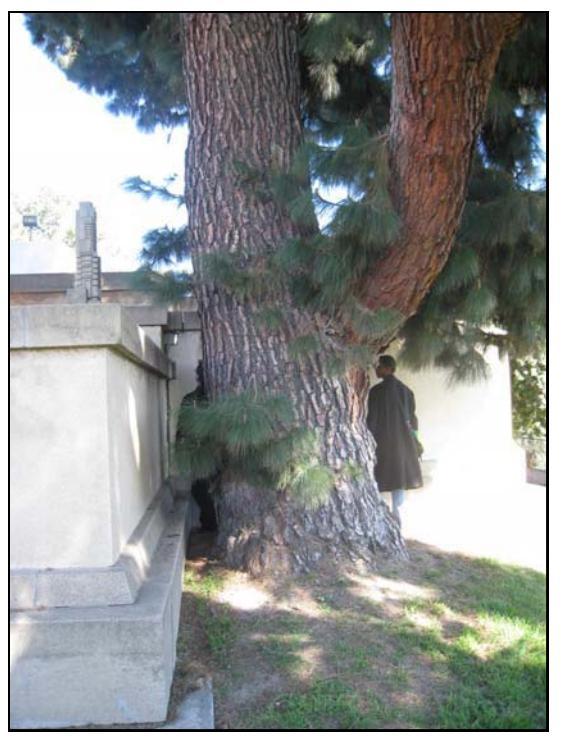
Figure 23: Patio wall on south side of Hollyhock House, view east. The large pine tree has started to lift up the wall foundation. (Photo credit: Chattel Architecture, 2009)

The roots of the large pine tree on the south side of the building near the Conservatory is lifting up the garden walls in the area. This has resulted in both vertical and horizontal displacement of the walls, vertical cracks in the wall, and the potential for the wall to collapse. There is the future possibility for loss of the historic wall, plus the small chance that it could collapse on a visitor when someone leans against it.

Remove the tree and root system. Plant a new tree further from the building. Investigate how many more years the tree can be expected to live. Removal would be the preferred option since it protects the structure. A new tree would replace the lost shade in a few years.

Rebuild the wall and provide for continued root growth. In this option the foundation of the wall would be constructed as a reinforced concrete beam. The beam would be under and over the existing root and provided with an opening that would permit some growth of the root. Ultimately, the root would continue to grow and the problem would reoccur.

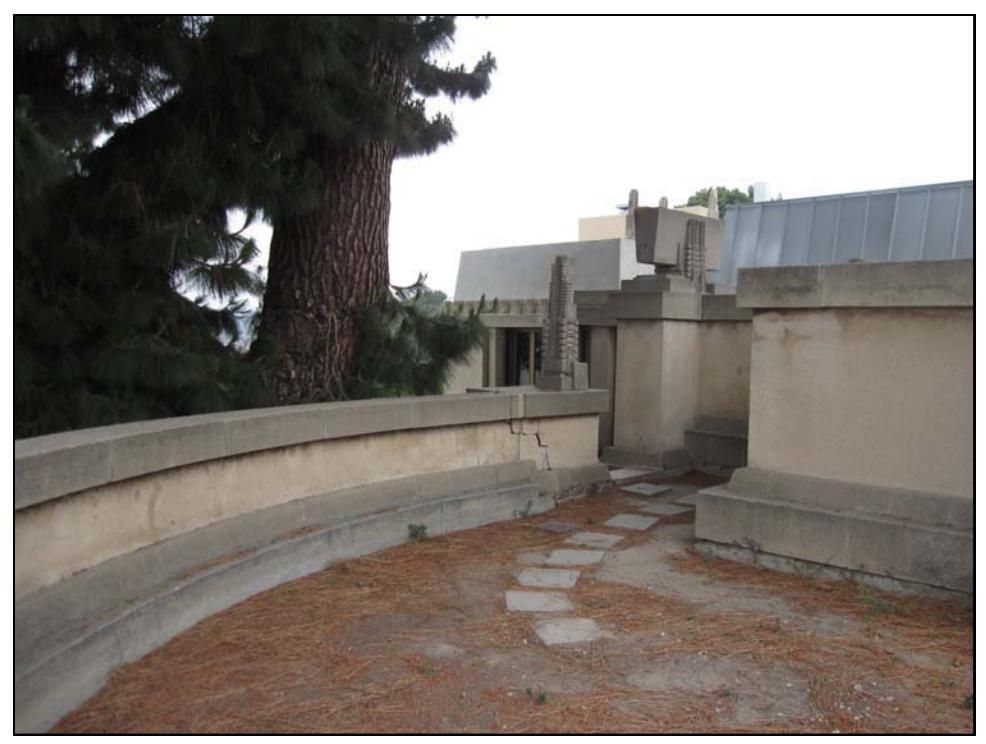
Figure 25: Patio wall showing large crack, view northwest. The tree's proximity to Hollyhock house also poses a threat should the tree fall. (Photo credit: Chattel Architecture, 2009)

Another factor is the trunk of the tree. It is close enough to damage the building.

If the tree fell in a wind storm the uplifting roots would do significant damage to the building.

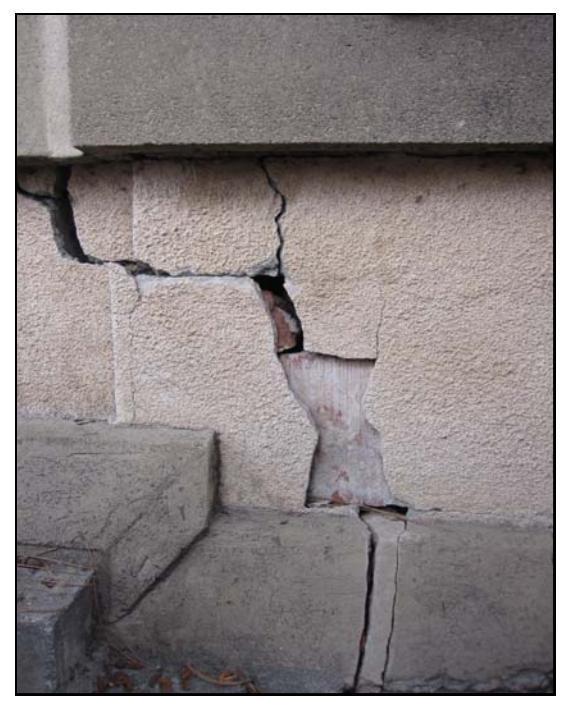
Figure 26: Detail of crack along patio wall. (Photo credit: Chattel Architecture, 2009)

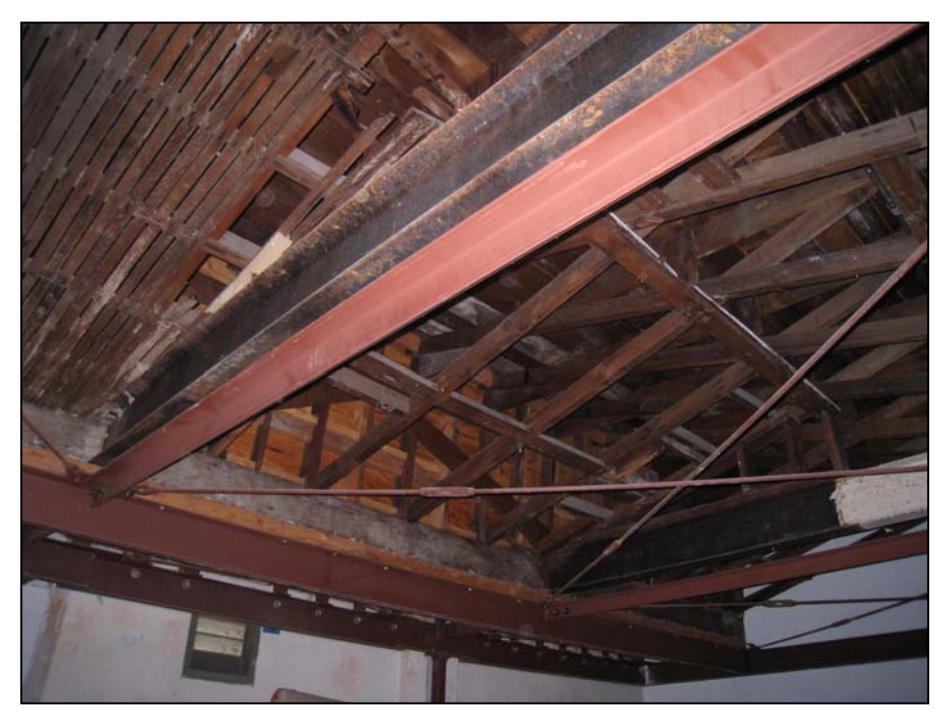
Figure 29: Interior of garage building, view southwest. The automobile area roof consists of a wood truss system which has been retrofitted with a horizontal steel truss. (Photo credit: Chattel Architecture, 2009)

The FEMA repair work brought this building into full compliance with the Los Angeles Building Code Division 88. The retrofit work consisted of the installation of a horizontal steel truss to act as a diaphragm. The walls are anchored and braced by the horizontal truss system. In the living quarters, the walls are anchored to the plywood or to the straight board-sheathed diaphragm. Between the garage and living quarters there are drag elements to distribute the load and to tie the two halves of the building together.

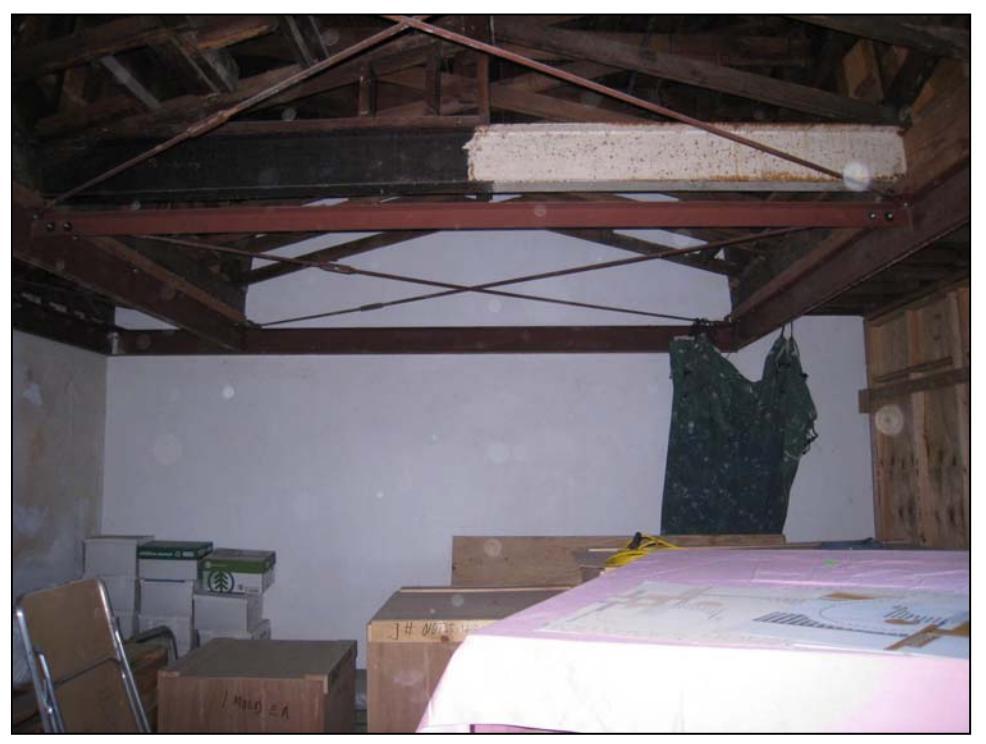
Figure 31: A plywood shear wall has been constructed between the automobile area and living quarters, view east. (Photo credit: Chattel Architecture, 2009)

A plywood shear wall was constructed on the wall between the garage and living quarters and extends from the foundation to the roof. Independent supports were placed below the steel beams over the garage openings.

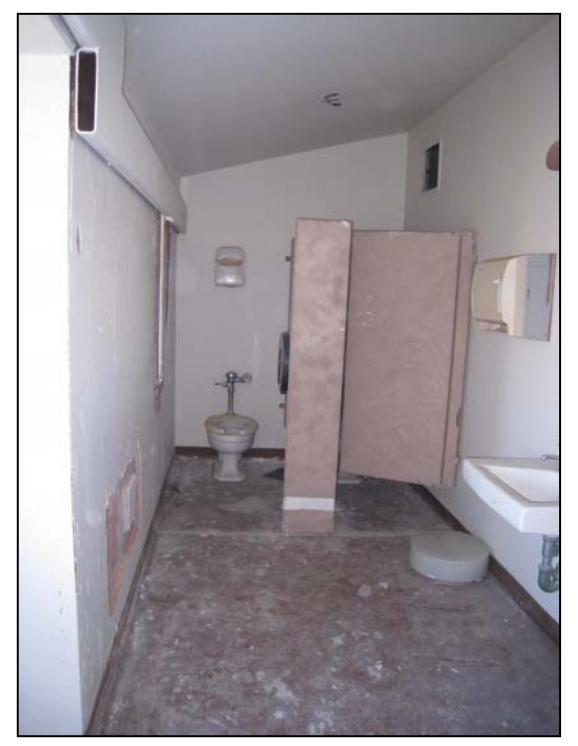
Figure 34: Interior of garage living quarters, view northeast. It is likely that the existing historic concrete material would have to be covered to conform with existing code requirements. (Photo credit: Chattel Architecture, 2009)

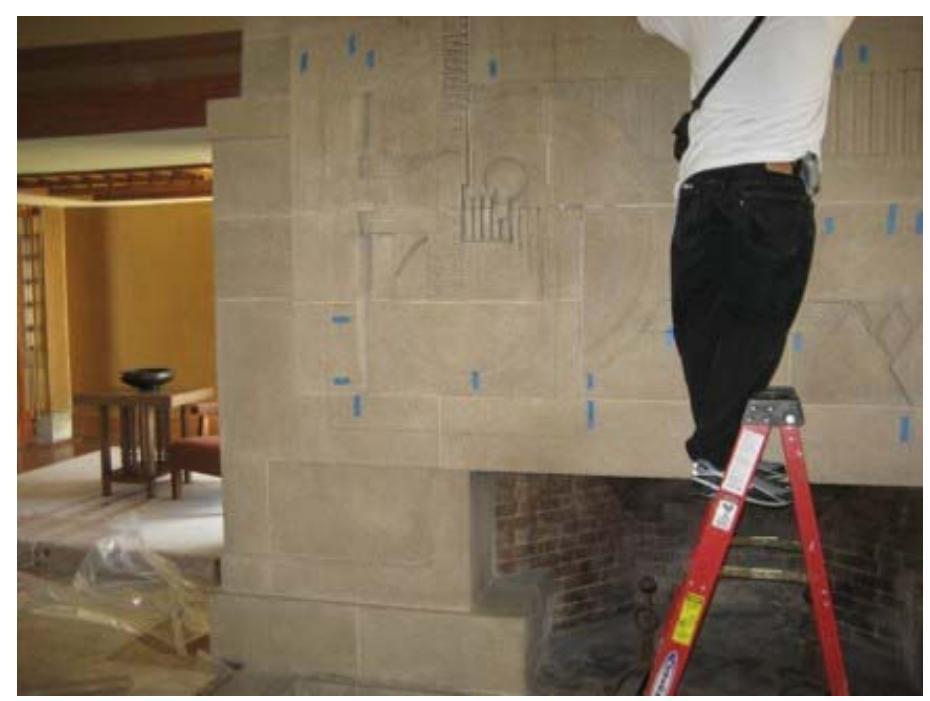
The test program by Smith Emery Laboratories, which used ground penetrating radar devices, found some existing metal ties. This is seen in the following photographs. The test results did not find the expected pattern of anchors at each corner. Some lines indicated metal, and only one horizontal line showed a pattern. It is possible that the anchors from the stone to the fireplace are non-ferrous material and do not show up on the test devices. At this point the tests are non-conclusive. Any other test method would require destructive investigation.

Photo 3. Living room fireplace showing tape where testing indicates metal is present

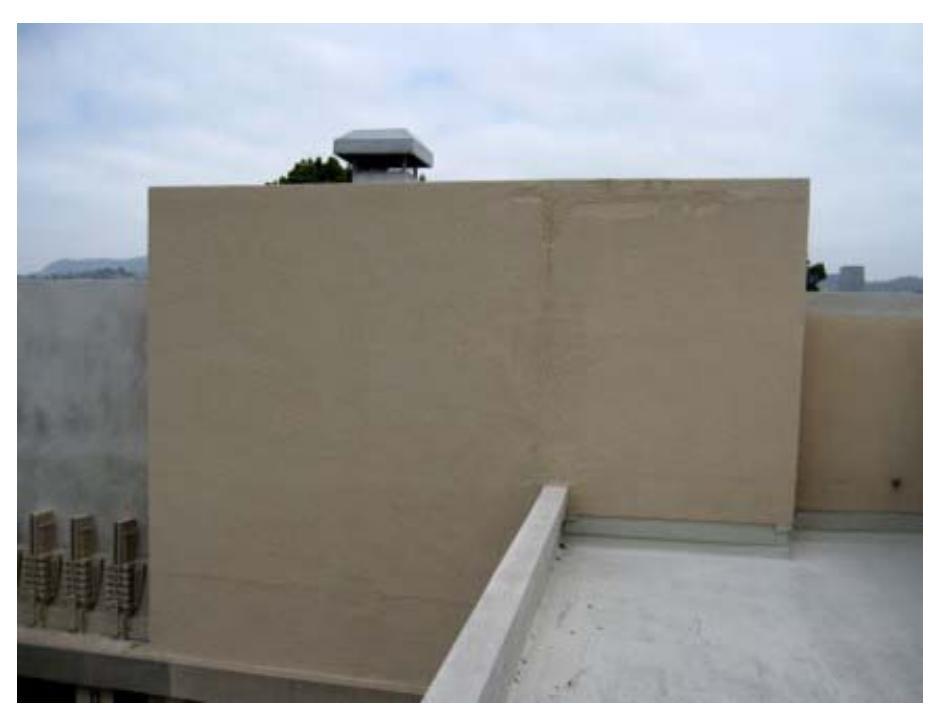
The second issue is the chimney, shown in photo 4. It is constructed of unreinforced masonry. Chimneys of this type have collapsed in past earthquakes. The movement of the chimney in the 1994 Northridge earthquake resulted in a horizontal crack in the stucco enclosure near the roof line on the building's exterior The Northridge earthquake also affected the decorative stone mural above the firebox in the building's interior.

Photo 4. Living room fireplace from roof. Note vertical crack where fireplace and wood extension join.

The solution would be to improve the fireplace foundation. There are several options to consider.

One option is to construct a caisson pile system beneath the existing fireplace foundation and extend it into bedrock. A concrete grade beam would connect the caissons together and transfer the fireplace weight to the caissons.

Another option would be to improve the soil under the foundation. This involves the injection of a cement mix to strengthen the soil and, in effect, create a "soil-cement" foundation. This solution would greatly improve the support for the fireplace and significantly reduce the potential for settlement.

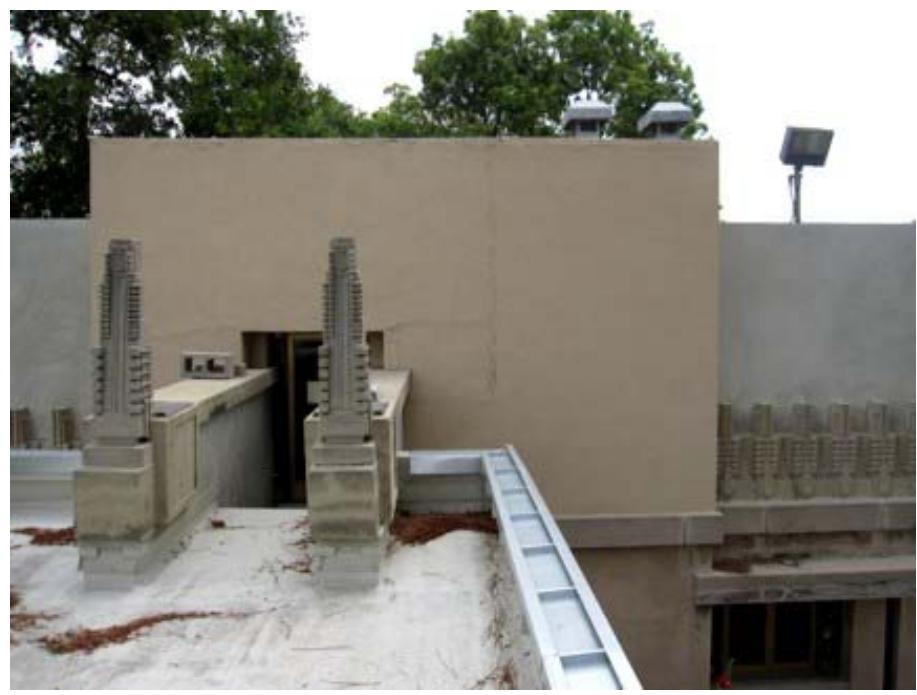
The width of the fireplace is oriented in a the north south direction along gridline 3 in the plan view. The mass of the chimney resulted in lateral movement causing

Photo 5. Child's Room fireplace. Shows vertical crack at joint of hidden chimney and building.

some minor cracks in the wall adjacent to the fireplace.

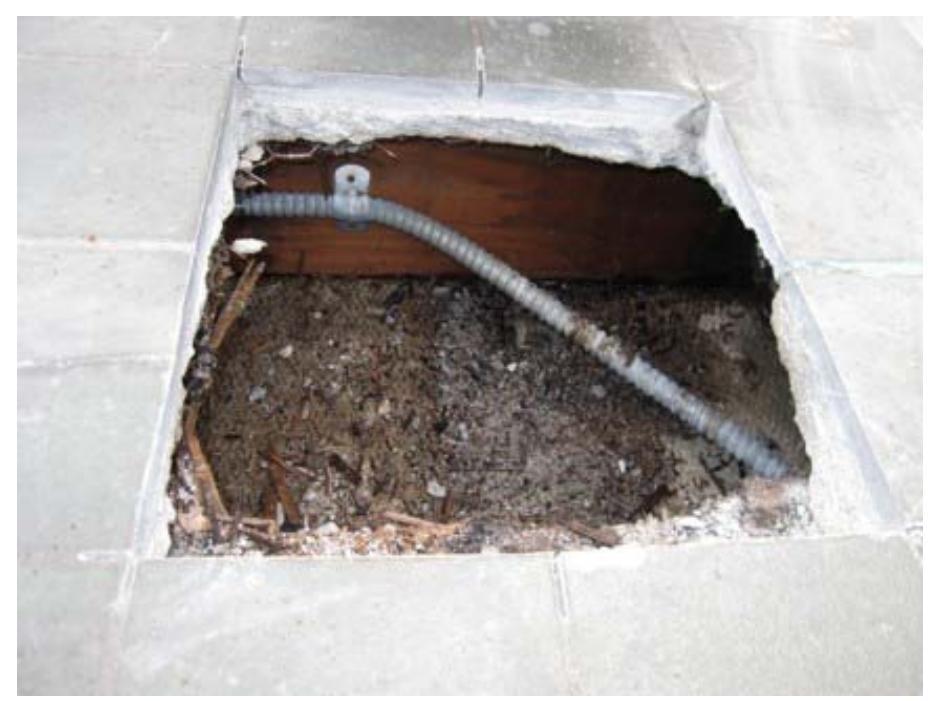
The framing of this building is light. In this case, the joists are subject to a heavier than normal dead load. Calculations indicate possible excessive deflection under dead load. Wood also has a tendency to "relax" over the years and deflect more than anticipated.

Photo 6. Tile deck showing inspection opening. Note rotted plywood pieces.
