HISTORIC STRUCTURE REPORT

RESIDENCE A AT BARNSDALL PARK

CITY OF LOS ANGELES

TASK I, II, AND III FINAL

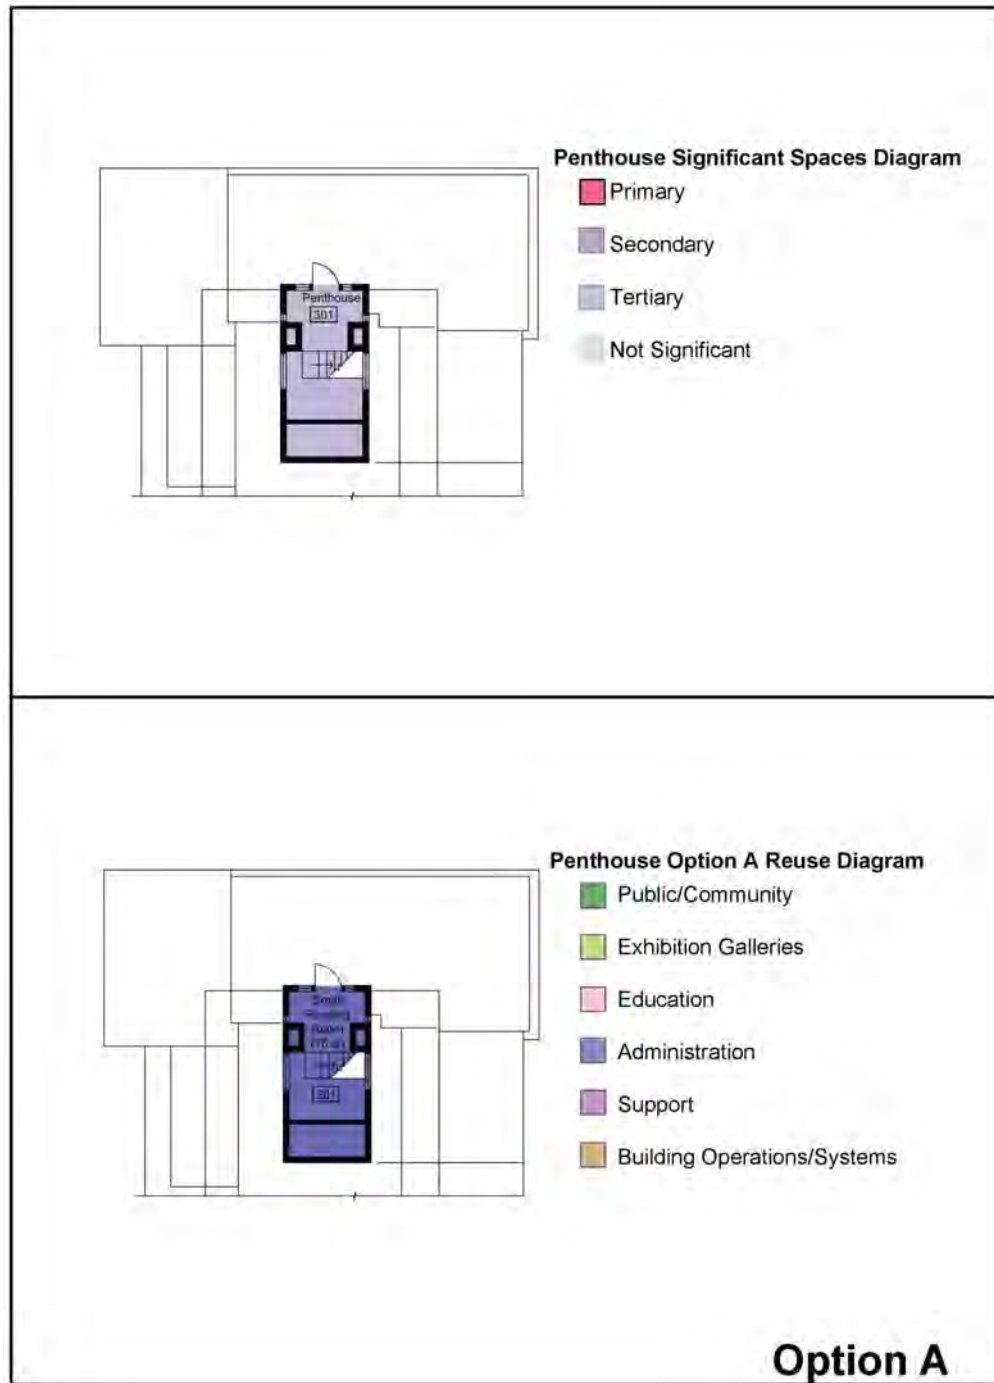
Penthouse Floor Level

Penthouse (Room 301). As shown above, this space could provide additional space, if necessary, for storing materials related to archival processing and it could also function as a small reading room.

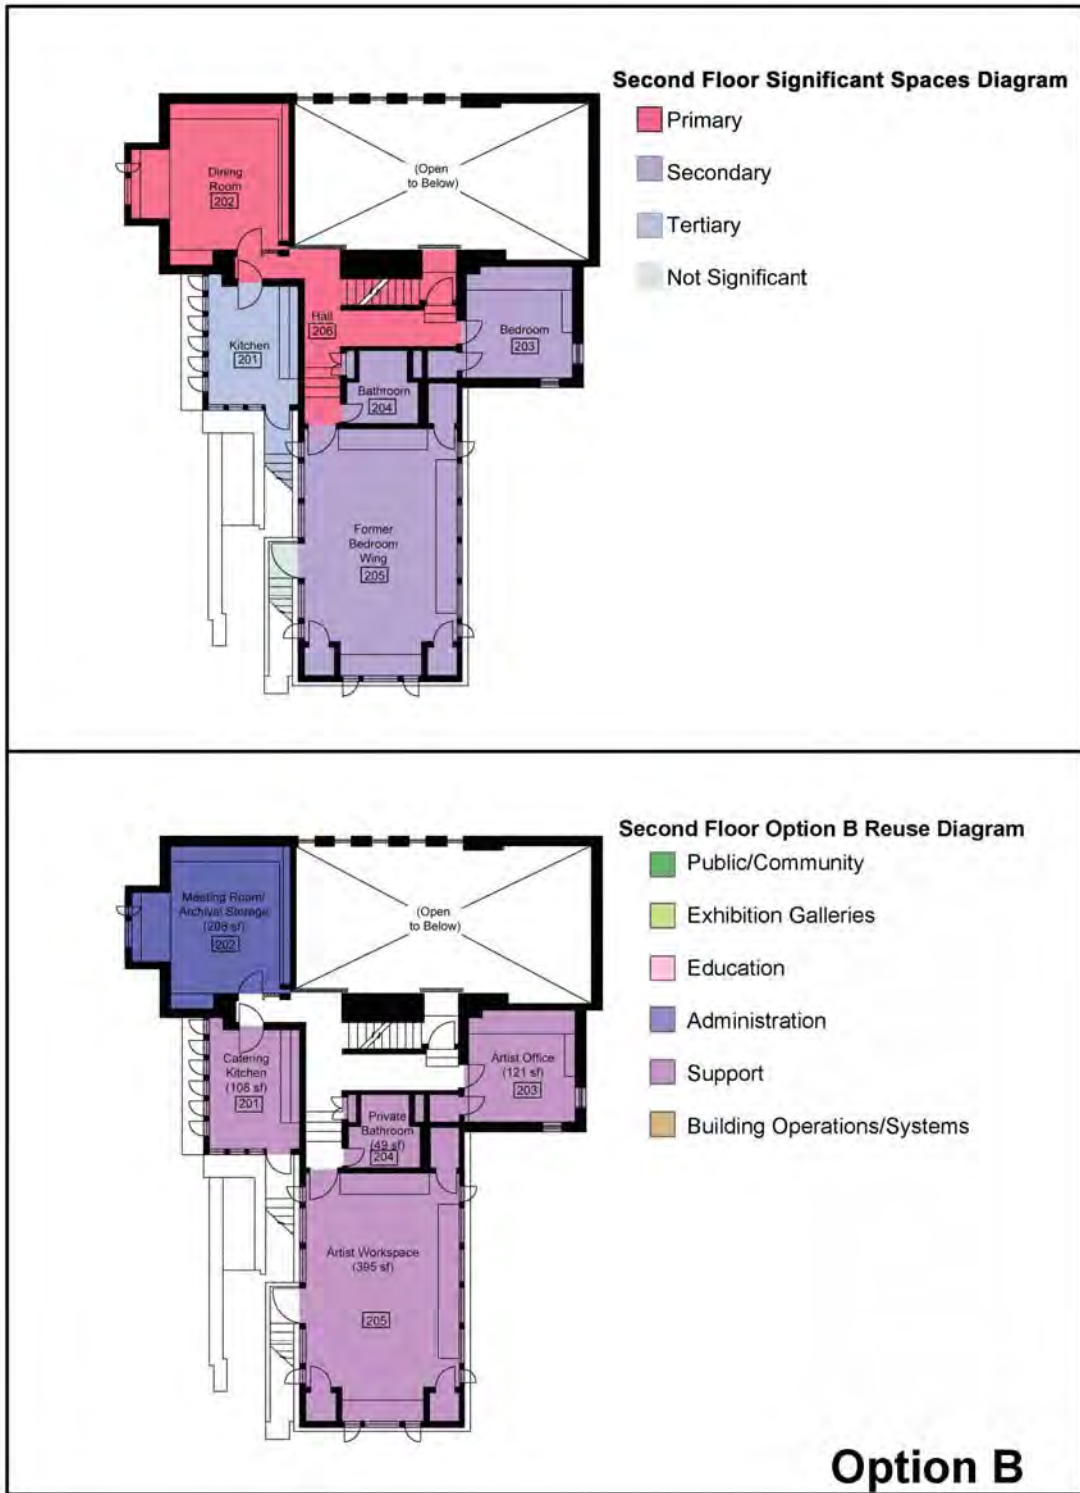
Second Floor Level

As shown above, in Option B, the second floor would not be open to the public and would be dedicated primarily to the needs of the artist-in-residence.

Bathroom (Room 204). This space would continue its use as the only bathroom on the second floor. This bathroom would most likely include a shower, allowing for staff to prepare for special events on site at Barnsdall Park.

Former Bedroom Wing (Room 205). This space would be the artist-in-residence work space and studio. Although this room is not suited to accommodate the needs of an artist who works with materials such as paint, it would be ideal for an artist that deals with newer media such as sound and video. The artist-in-residence would have the entire space to work on multiple projects at once and would have the entire room to use as a studio.

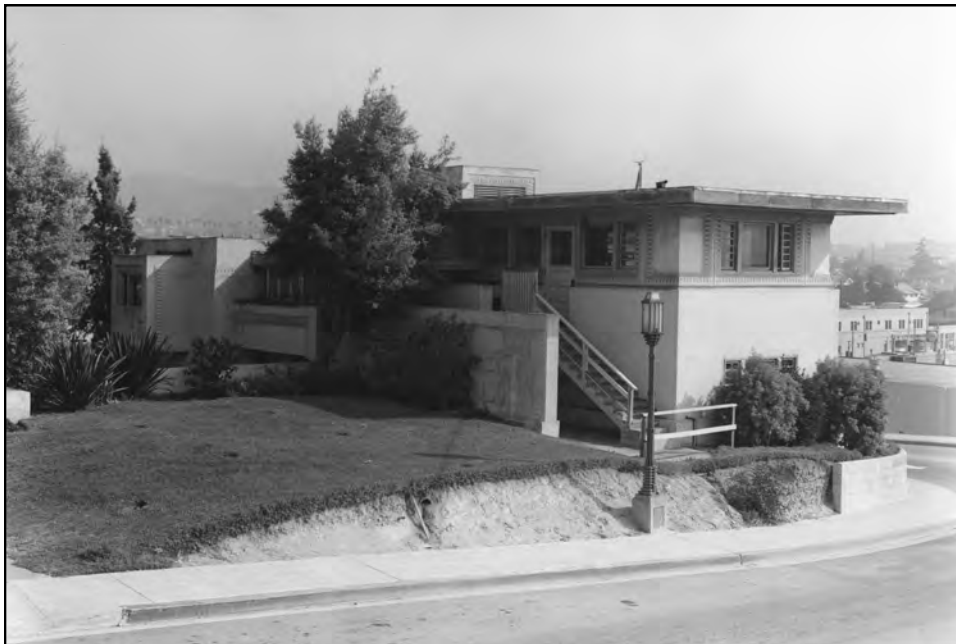
Figure 16: Photo of west and south elevations taken 1965, view northeast.
(Photo credit: Marvin Rand, Historic American Buildings Survey)

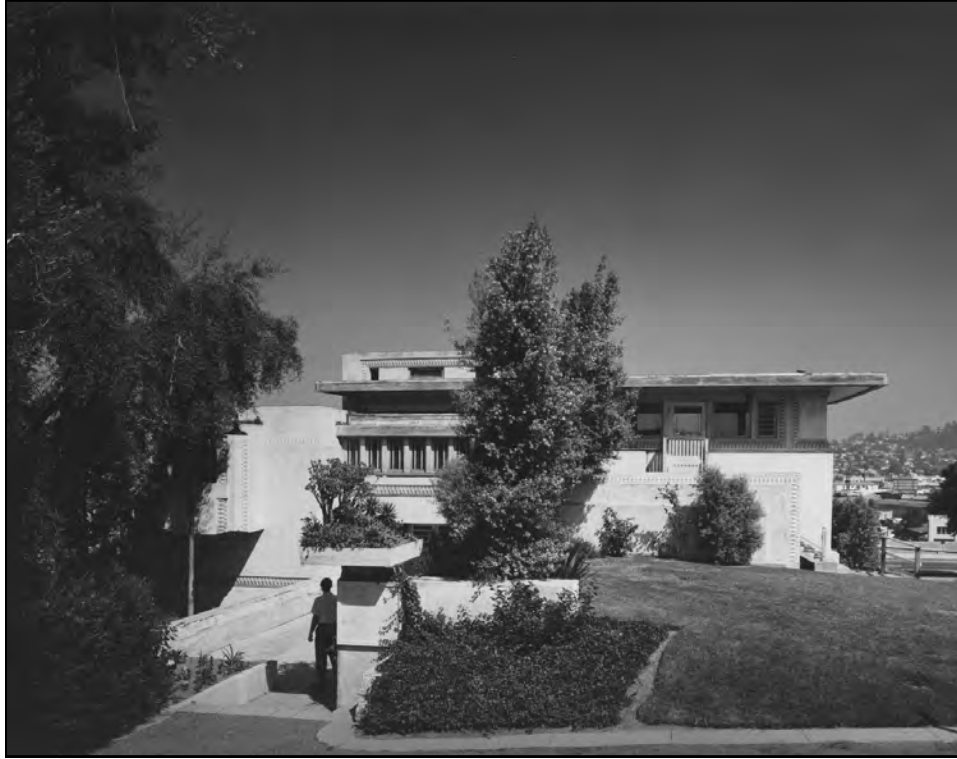
Figure 17: 1965 photo of west elevation, view northeast.
(Photo credit: Marvin Rand, Historic American Buildings Survey)

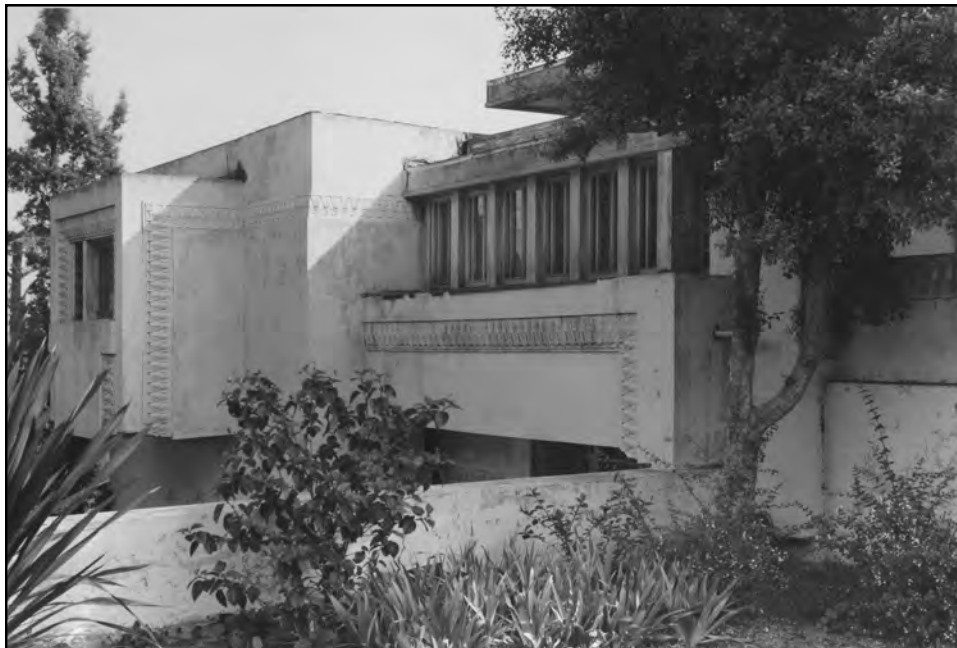
Figure 18: Detail of kitchen windows above entrance, photo taken in 1965.
(Photo credit: Marvin Rand, Historic American Buildings Survey)

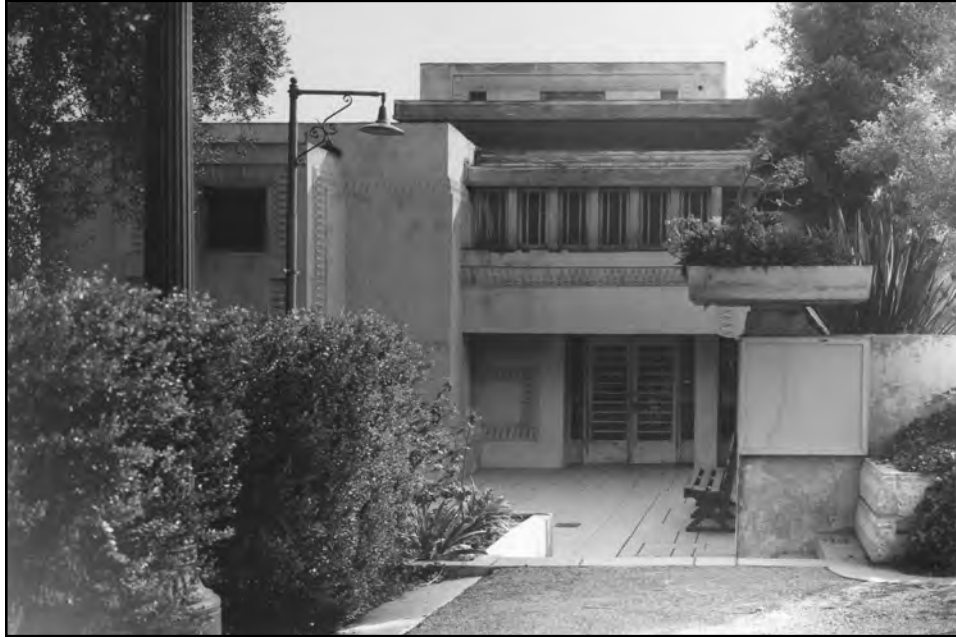
Figure 19: Detail view of entrance, photo taken 1965.
(Photo credit: Marvin Rand, Historic American Buildings Survey)

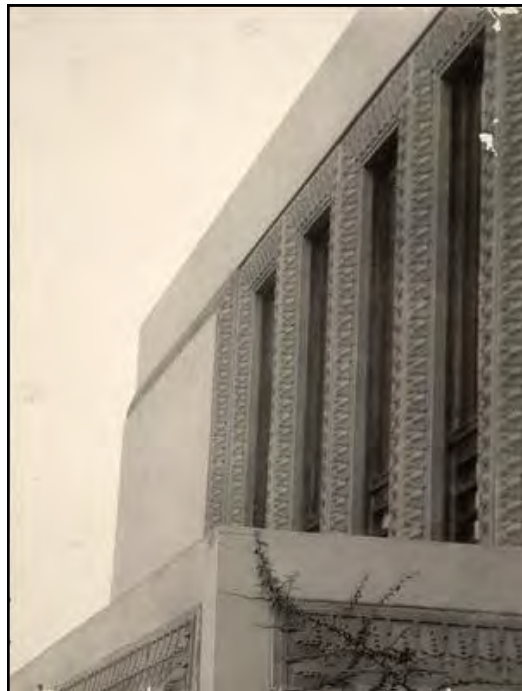
Figure 24: Historic photo showing original balcony, exact date unknown.
(Photo credit: Cornell Adwhite)

According to Glasgow, the original concrete balcony was replaced with the current wood balcony in 1950. This is possibly corroborated by Frank Lloyd Wright’s 1957 Master Plan drawing for Barnsdall Park, on which he noted his intention to restore the façade on the north elevation.¹ Another major alteration to the building was the addition of an upstairs entrance/exit and wooden stairway to the western elevation. Photographic evidence indicates that the staircase and door were added between 1954 and 1965.²

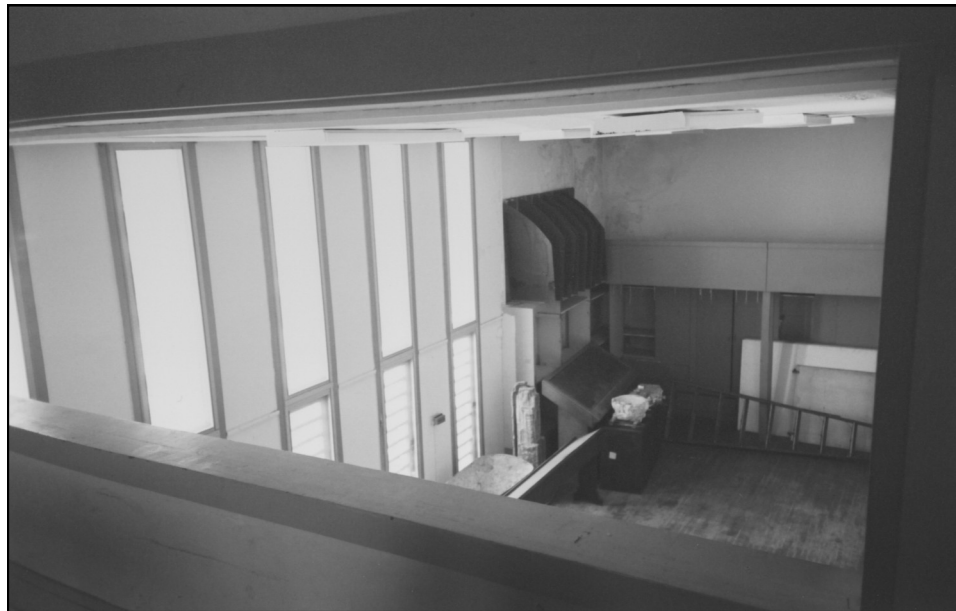
Figure 32: View of the living room looking down from the dining room. Photo taken ca. 2005.
(Photo credit: Thomas Koester for the Aline Barnsdall Complex National Historic Landmark Nomination)

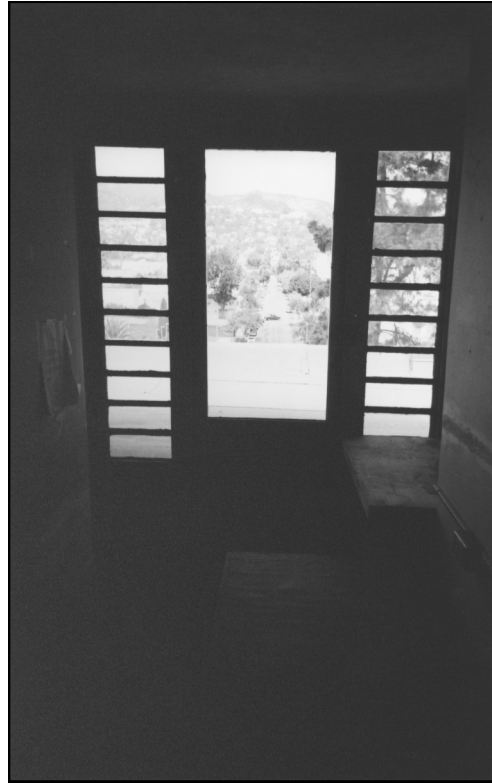
Figure 33: View through the penthouse door, ca. 2005.
(Photo credit: Thomas Koester for the Aline Barnsdall Complex National Historic Landmark Nomination)

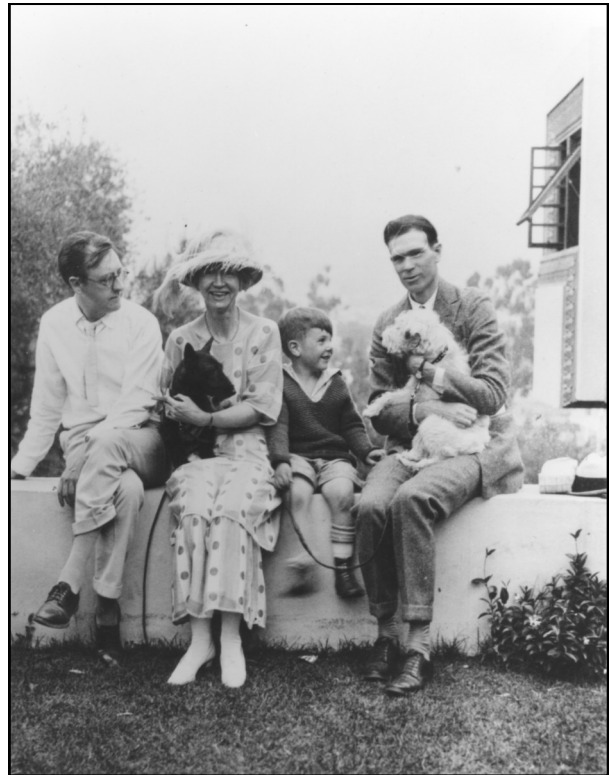
Figure 35: Undated photo of Louise Arensberg sitting on retaining wall south of the entryway, dining room bay window is visible on right of photo.
(Image credit: Beatrice Wood's personal collection)
